## **INTRODUCTION**

## **STUDY PURPOSE**

## **PHASE II SCOPE OF WORK AND TASKS**

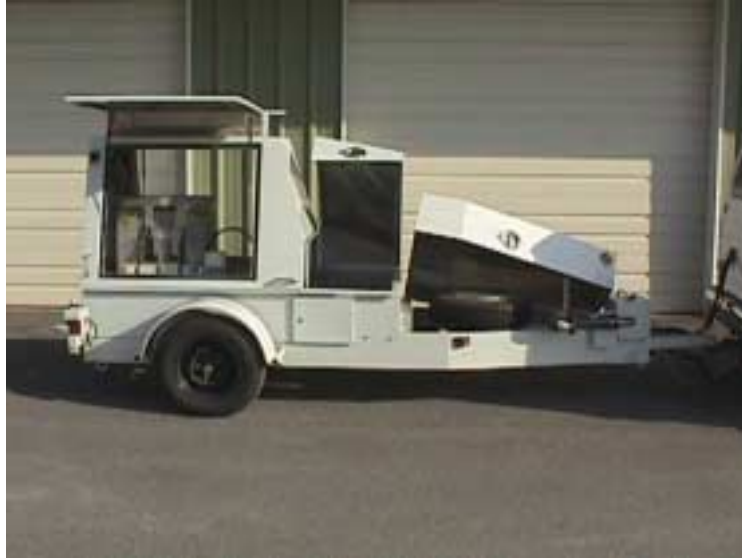
**Figure 1 – VDOT FWD**

In July and August, 2002, nondestructive deflection testing was conducted using the state owned and operated falling weight deflectometer (FWD) to develop an understanding of the structural

condition of the pavement (See Figure 1). Testing was only conducted between MP 173 and MP 254 in the outside lane for both directions. For the jointed concrete pavement sections, pavement basin testing and joint load transfer testing were performed. On the continuously reinforced concrete, composite and flexible pavement sections, basin testing was performed. Impulse loads of 6,000, 9,000, and 16,000 pounds were applied to the pavement and the resulting deflections were recorded at radial distances of 0", 8", 12", 18", 24", 36", 48", 60" and 72" measured from the center of the load plate.
